Interior/Exterior Survey

Move In Condition Summary

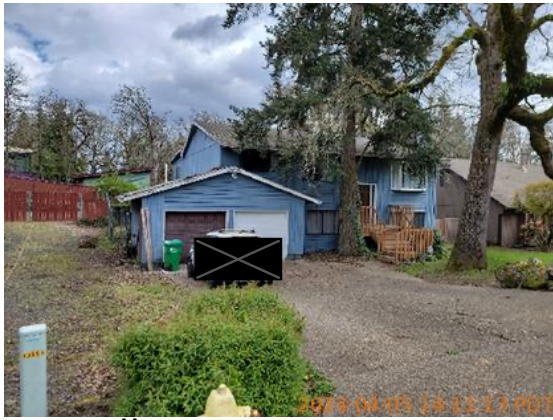
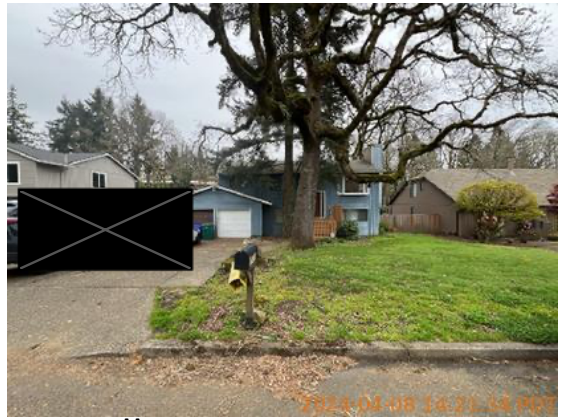
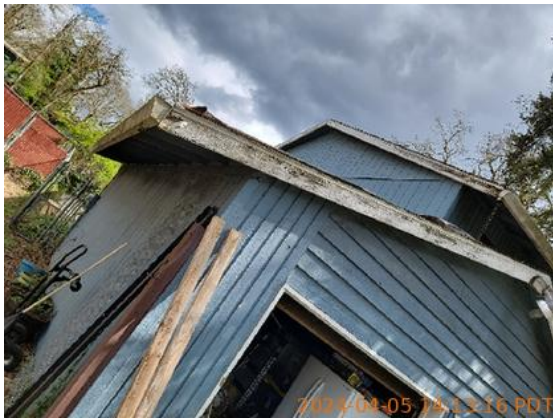
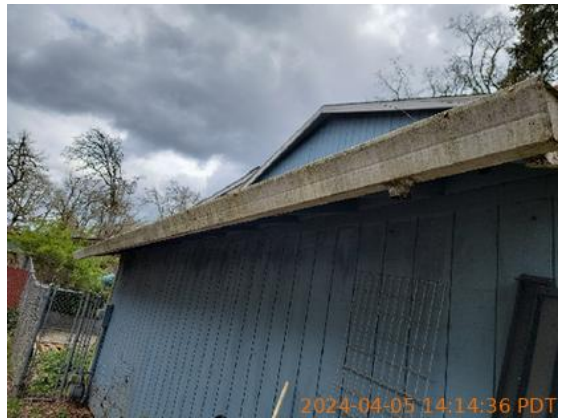
🏠 Front Yard/Exterior	🔗 CONDITION	🔧 ACTION	💬 COMMENTS
Building Exterior	- - D !	Maintenance	Paint peeling and wood rot on Facia board above garage. Moss growth on roof. Tarp on roof above garage. Faded paint on siding. Dirty gutter face. Debris in gutters.
Fence/Gate	- S - -	None	
Landscaping	- S - !	Landscaping	Patchy grass with weed growth and small amounts of debris in front yard. Ivy growth in front yard. Tree branches overhanging roof, need trimming.
Light Fixture	- S - -	None	
Mailbox/Keyed Location	- S - -	None	
Other	- S - -	None	Expired tags in driveway.
Patio Cover	- S - -	None	
Patio/Deck/Balcony	- S - -	None	
Porch/Stairs	- - D !	Maintenance	Paint chipping, minor moss growth, and disconnected hand rail on porch/stairs. Loose boards on porch stairs.
Walk/Driveway	- - D -	None	Cracks and chips in driveway. Weed growth in driveway. Needs pressure washing.

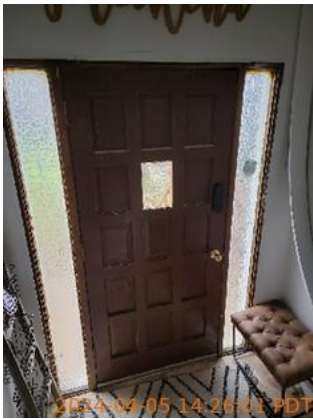
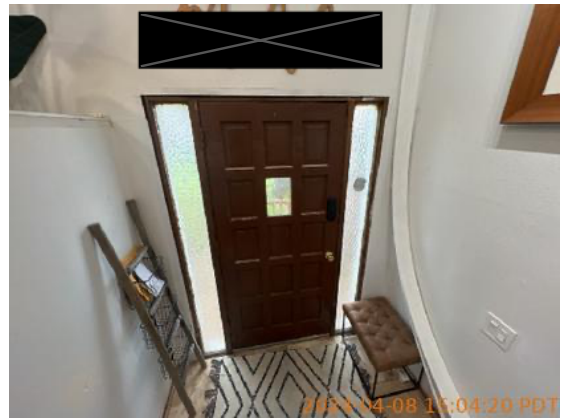
🚪 Entry	📍 CONDITION	🛠️ ACTION	💬 COMMENTS
Door/Knob/Lock	- - D -	None	Dirt buildup, dents, wood chipping, spider webs, worn paint, paint marks and unfinished surface around door & frame.
Doorbell	- S - -	None	
Flooring/Baseboard	- - D -	None	Gaps in floor tile. Grout stains on floor.
Light Fixture/Fan	- S - -	None	
Other	- S - -	None	Wood boards stored at entry.
Switch/Outlet	- S - -	None	
Wall/Ceiling	- - D !	Maintenance	Marks and stains on walls. Visible repair on wall.

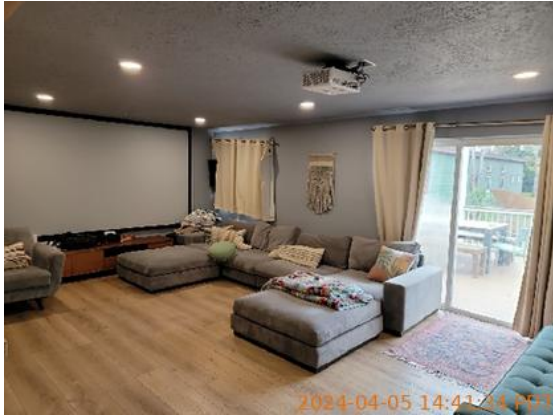
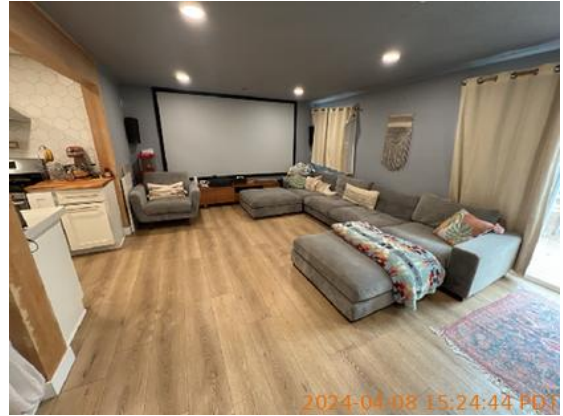
🏠 Living Room	📍 CONDITION	🛠️ ACTION	💬 COMMENTS
Door/Knob/Lock	- S - -	None	
Flooring/Baseboard	- S - -	None	
Light Fixture/Fan	- S - -	None	
Other	- - D -	None	Projector and projector screen added to living room. Paint marks on wood pillars connected to kitchen. Gaps and cracks on wood pillar connected to kitchen.
Switch/Outlet	- S - -	None	
Wall/Ceiling	- - D -	None	Hole in ceiling.
Window Covering	- - D -	None	Curtain rail bracket falling out of wall.

Living Room	CONDITION	ACTION	COMMENTS
Window/Lock/Screen	- S - -	None	
Smoke/CO Detector	- - D !	Maintenance	Missing smoke detector.

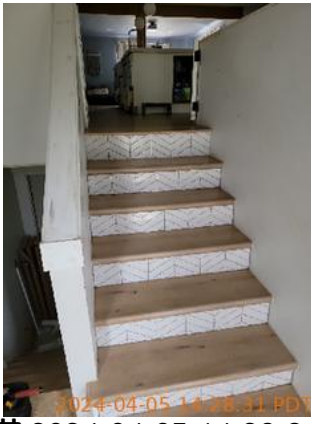
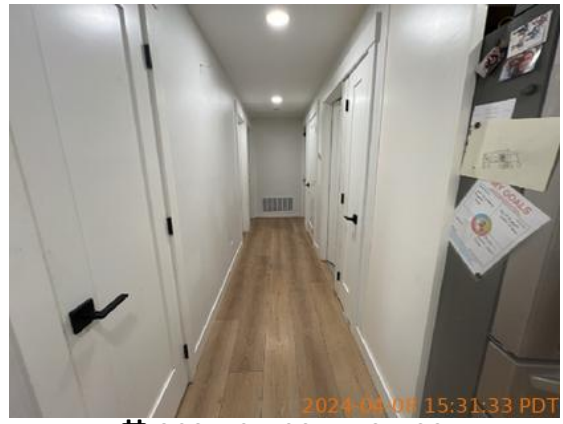
🏠 Hallway/Stairs	📍 CONDITION	🛠️ ACTION	💬 COMMENTS
Closet/Cabinet	- - D -	None	Stains, paint chipping, and wood cracking on closet door.
Flooring/Baseboard	- S - -	None	Stains on wood stairs.
Light Fixture	- S - -	None	
Other	- S - !	Maintenance	Hallway vent is missing a screw.
Railing/Banister	- S - -	None	Very dirty and stained rail.
Smoke/CO Detector	- - D !	Maintenance	Missing smoke alarm.
Switch/Outlet	- S - -	None	
Wall/Ceiling	- - D !	Maintenance	Wiring coming out of hole in wall. Unfinished doorframe.

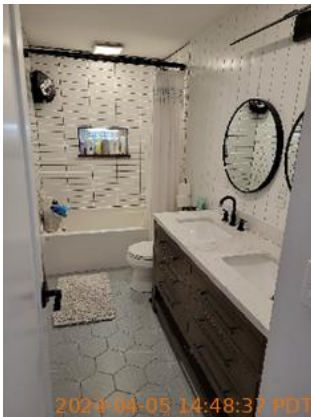
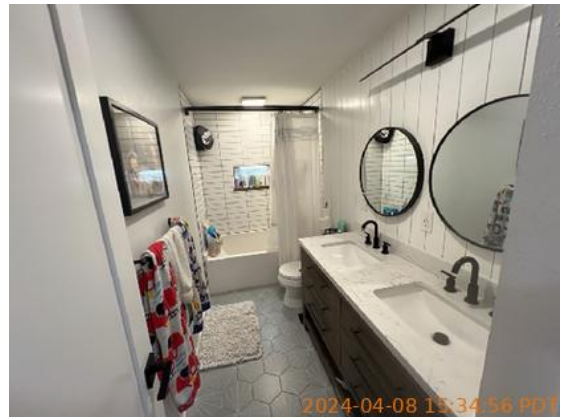
🚪 Bathroom: Hallway	📍 CONDITION	🔧 ACTION	💬 COMMENTS
Cabinet/Counter/Shelving	- - D !	Maintenance	Cracked caulking where countertop meets wall. Worn finish on cabinets.
Door/Knob/Lock	- S - !	Maintenance	Stains on door. Door needs door stopper.
Exhaust Fan	- S - -	None	Dirty exhaust fan.
Flooring/Baseboard	- S - -	None	Discolored grout on flooring.
Light Fixture	- S - -	None	
Other	- S - -	None	
Plumbing/Drain	- S - -	None	
Shower Door/Rail/Curtain	- S - -	None	
Sink/Faucet	- S - -	None	
Switch/Outlet	- S - -	None

Bathroom: Hallway	CONDITION	ACTION	COMMENTS
Toilet	- S - -	None	
Toilet Paper Holder	- S - -	None	
Towel Rack	- S - -	None	
Tub/Shower	- S - -	None	Discolored grout at base of tub.
Wall/Ceiling	- - D !	Maintenance	Chipped paint on wall corner edge. Stains on walls. Dent in wall from door handle.

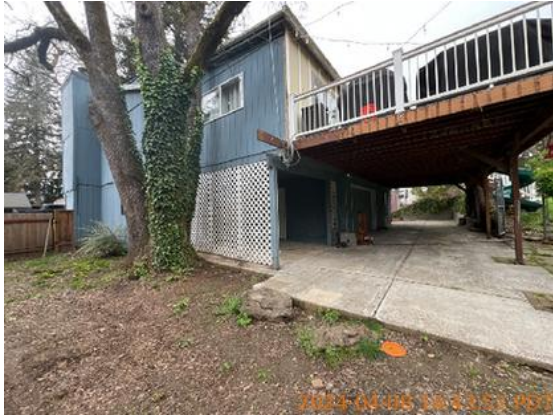
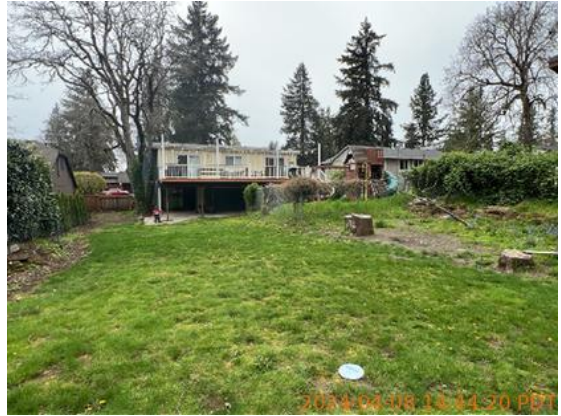
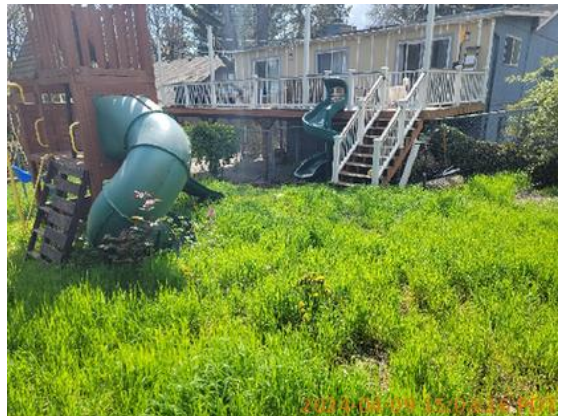
🏠 Back Yard/Exterior	📌 CONDITION	🔧 ACTION	💬 COMMENTS
Building Exterior	- - D !	Landscaping	Ivy growth on siding. Paint chipping on east siding. Missing piece of downspout on NE corner. East side gutter face is dirty and roof flashing is showing rust. Stains and worn paint on East siding.
Fence/Gate	- - D !	Maintenance	Wood gate held closed by rocks. Gate missing latch to close gate properly. Plants growing on east chain link fence. Neighbors ivy growing on far east chain link fence.
Landscaping	- S - !	Landscaping	Bare/patchy grass. Ivy growth in backyard. Weed growth in backyard. Debris in backyard. Overgrown grass area. Stumps and rocks in backyard pose tripping hazard. Divot in backyard poses as a tripping hazard. NE corner of property is overgrown with vines.
Light Fixture	- S - -	None	
Other	- S - !	Other	Frisbee golf net added to back yard. Logs piled up on east side of property. Kayaks stored on back patio. Wood boards stored on back patio. Play structure added to back yard. Slide added to backyard/deck. Lights added to back deck.

Patio Cover	- S - -	None	
Patio/Deck/Balcony	- - D -	None	Cracks and chips in back concrete patio. Minor moss growth on back patio. Back patio is worn overall. Stains on back deck. Miss match paint on sliding glass door frame.
Porch/Stairs	- S - -	None

Walkway	- - D -	None	Walkway from patio to deck stairs is cracked and overgrown.
---------	---------	------	---

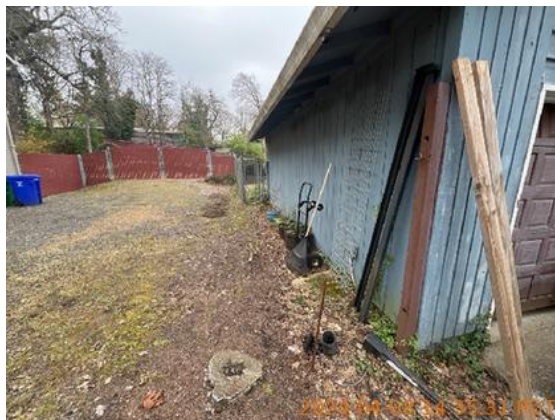
Side Yard/Exterior	CONDITION	ACTION	COMMENTS
Building Exterior	- - D !	Maintenance	Materials rested on siding. Missing north side downspout. Dirty gutter face. Debris in gutters.
Fence/Gate	- S - -	None	
Landscaping	- S - !	Landscaping	Moss, ivy growth, and dead leaves in North side yard.
Light Fixture	- S - -	None	
Other	- S - -	None	
Patio/Deck/Balcony	- S - -	None

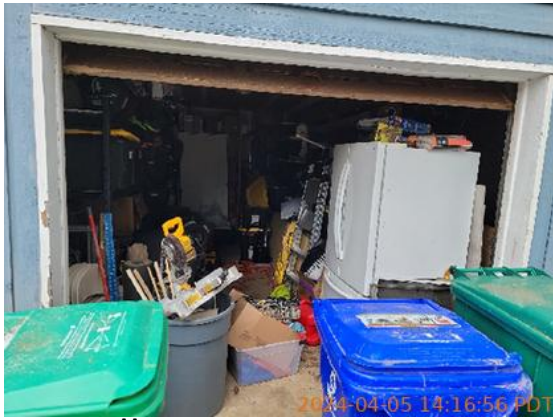
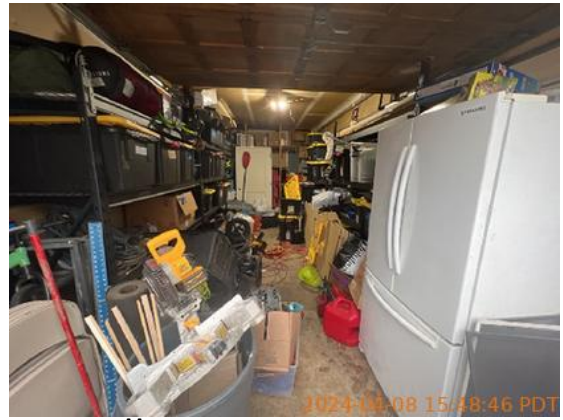
🏠 Garage/Parking	📌 CONDITION	🛠️ ACTION	💬 COMMENTS
Cabinet/Counter	- S - -	None	
Driveway/Floor	- - D -	None	Stained and cracked floor.
Electrical/Exposed Wiring	- - D !	Maintenance	Visible wiring in wall behind breaker box.
Garage Door	- - D -	None	Miss match garage doors. Paint chipping, stains, and wood rot on garage door & frames.
Light Fixture	- S - -	None	
Other	- - D -	None	Garage used for storage. Panels cut out of wall.
Other Door/Knob/Lock	- S - -	None	
Other Storage/Shelving	- S - -	None	
Switch/Outlet	- - D !	Maintenance	Ceiling outlet missing cover plate.
