Interior/Exterior Survey

Move In Condition Summary

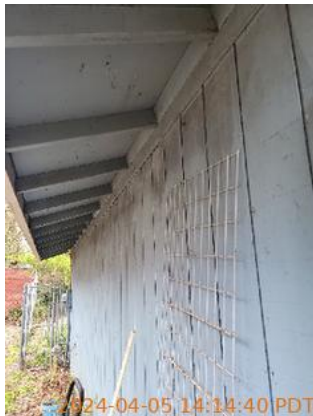
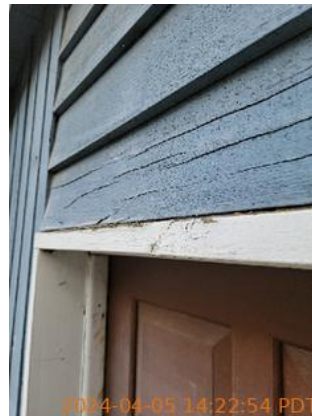
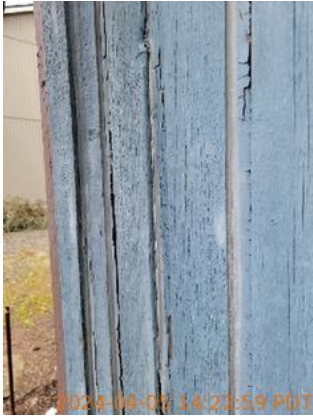
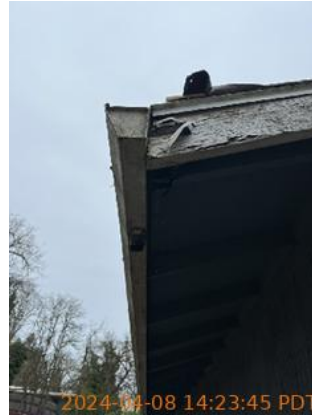
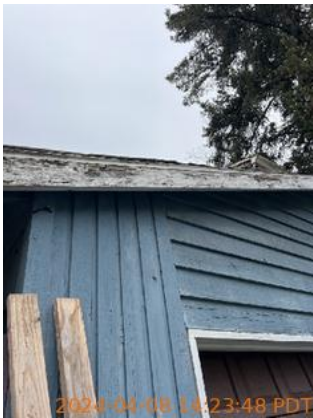
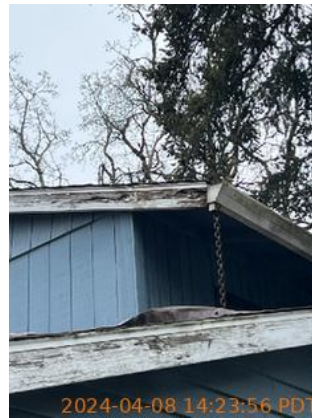
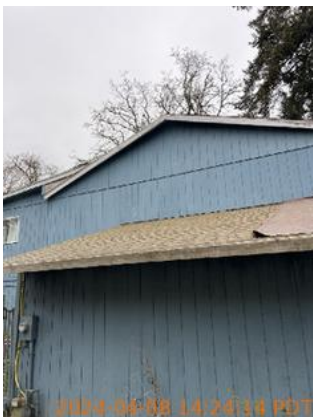
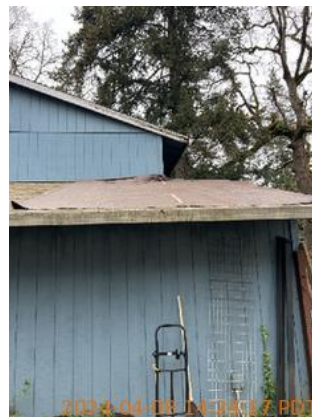
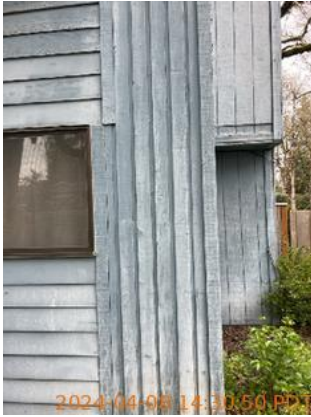
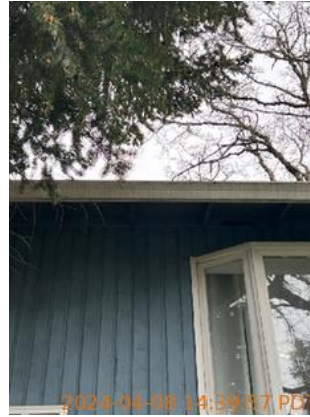
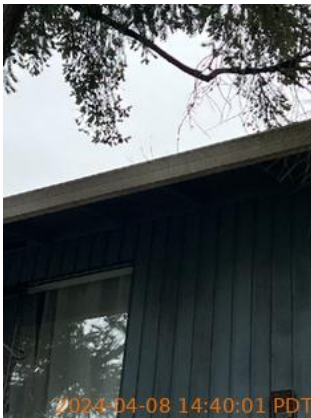
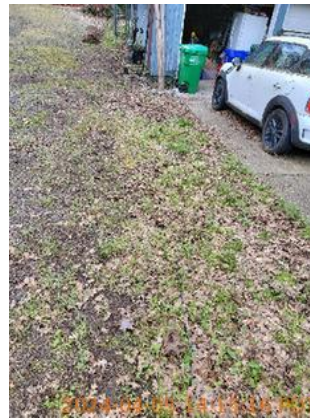
🏠 Front Yard/Exterior	🔗 CONDITION	🔧 ACTION	💬 COMMENTS
Building Exterior	- - D !	Maintenance	Paint peeling and wood rot on Facia board above garage. Moss growth on roof. Tarp on roof above garage. Faded paint on siding. Dirty gutter face. Debris in gutters.
Fence/Gate	- S - -	None	
Landscaping	- S - !	Landscaping	Patchy grass with weed growth and small amounts of debris in front yard. Ivy growth in front yard. Tree branches overhanging roof, need trimming.
Light Fixture	- S - -	None	
Mailbox/Keyed Location	- S - -	None	
Other	- S - -	None	Expired tags in driveway.
Patio Cover	- S - -	None	
Patio/Deck/Balcony	- S - -	None	
Porch/Stairs	- - D !	Maintenance	Paint chipping, minor moss growth, and disconnected hand rail on porch/stairs. Loose boards on porch stairs.
Walk/Driveway	- - D -	None	Cracks and chips in driveway. Weed growth in driveway. Needs pressure washing.

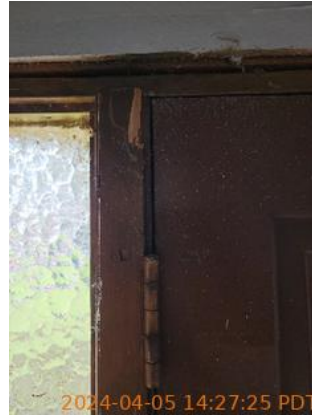
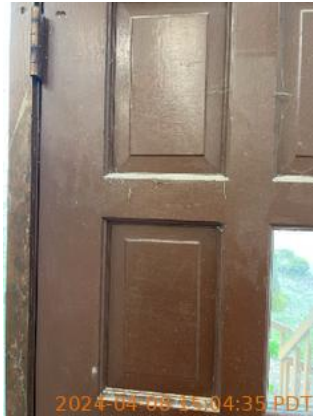
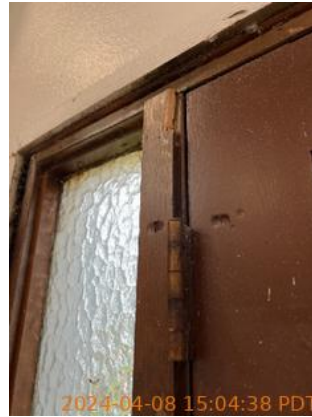
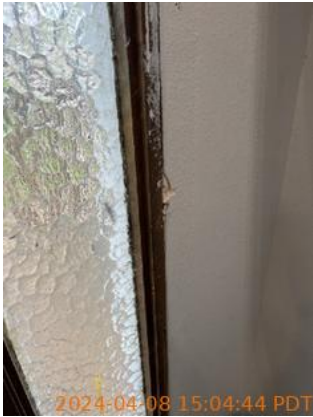
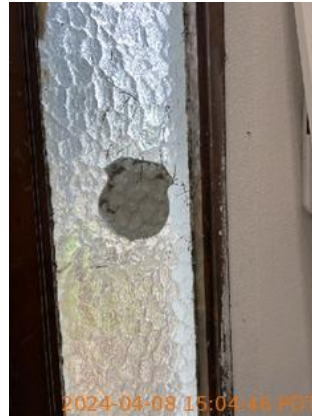
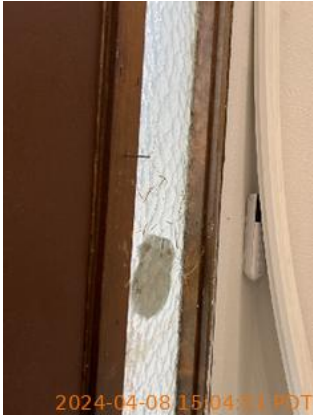
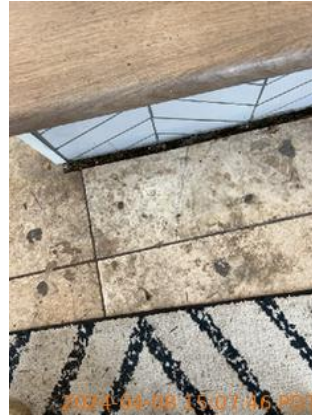
🚪 Entry	📍 CONDITION	🛠️ ACTION	💬 COMMENTS
Door/Knob/Lock	- - D -	None	Dirt buildup, dents, wood chipping, spider webs, worn paint, paint marks and unfinished surface around door & frame.
Doorbell	- S - -	None	
Flooring/Baseboard	- - D -	None	Gaps in floor tile. Grout stains on floor.
Light Fixture/Fan	- S - -	None	
Other	- S - -	None	Wood boards stored at entry.
Switch/Outlet	- S - -	None	
Wall/Ceiling	- - D !	Maintenance	Marks and stains on walls. Visible repair on wall.

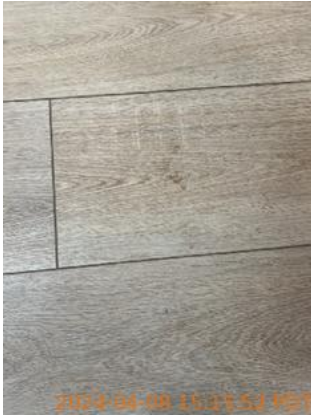
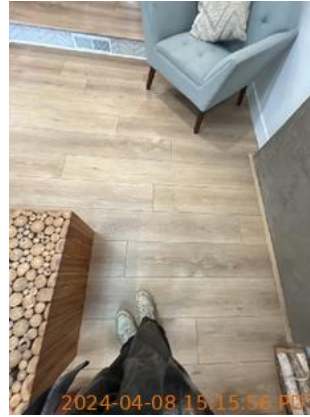
🏠 Family Room	📌 CONDITION	🛠️ ACTION	💬 COMMENTS
Door/Knob/Lock	- S - -	None	
Flooring/Baseboard	- S - -	None	Small stains on floor.
Light Fixture	- S - -	None	
Other	- S - -	None	
Switch/Outlet	- S - -	None	
Wall/Ceiling	- - D -	None	Mark on ceiling. Spider webs built up on ceiling. Scratched paint on wall from chair.
Window Covering	- S - -	None	
Window/Lock/Screen	- S - -	None	
Smoke / CO detector	- S - -	None

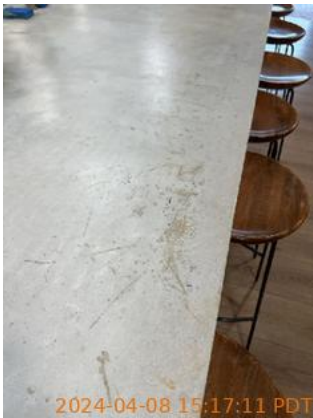
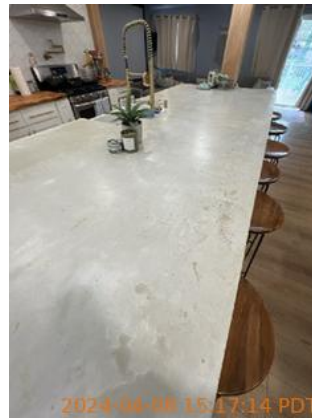
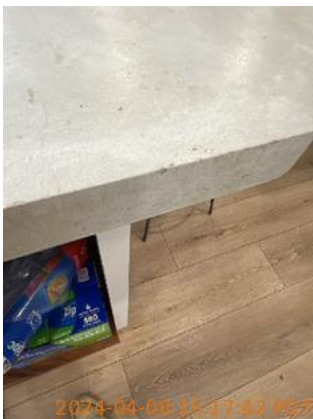
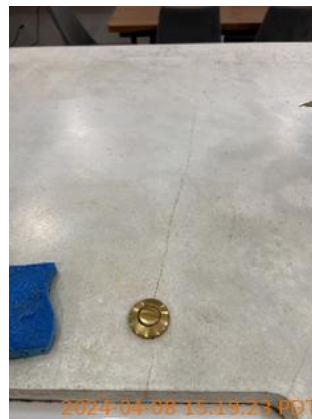
Kitchen	  CONDITION	  ACTION	  COMMENTS
Cabinets/Drawers	- S - -	None	Stains on cabinets.
Counter	- - D -	None	Scratched and marked finish on countertop. Chips on countertop edges. Crack in countertop.
Dishwasher	- S - -	None	Dishwasher is stained.
Faucet/Plumbing	- S - -	None	
Flooring/Baseboard	- S - -	None	
Light Fixture	- S - -	None	
Microwave	- S - -	None	Stains on microwave.
Other	- S - -	None	
Oven	- S - -	None	
Range/Fan/Hood/Filter: <i>Above oven, large size</i>	- - D !	Maintenance	Range fan not working.
Refrigerator	- S - -	None	Stained and dirty finish on fridge.
Sink/Disposal	- S - !	Maintenance	Stains on sink finish. Organic growth around sink caulking.
Switch/Outlet	- S - -	None	
Wall/Ceiling	- S - -	None

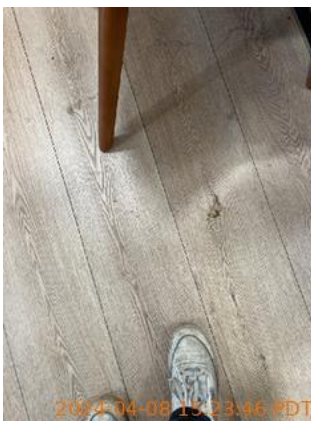
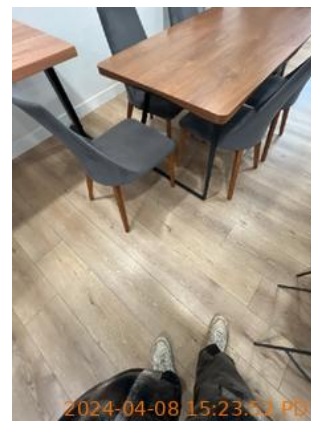
Dining Room	CONDITION	ACTION	COMMENTS
Flooring/Baseboard	- S - -	None	Stains and scratches on floor.
Light Fixture/Fan	- S - -	None	
Other	- S - -	None	
Switch/Outlet	- S - -	None	
Wall/Ceiling	- - D -	None	Dent in wall leading to living room. Scuff marks on wall.

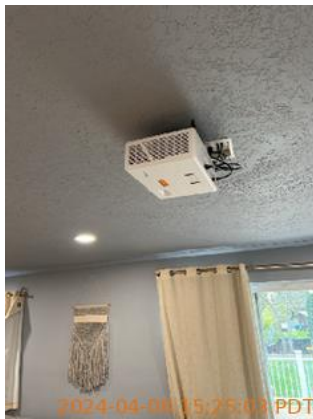
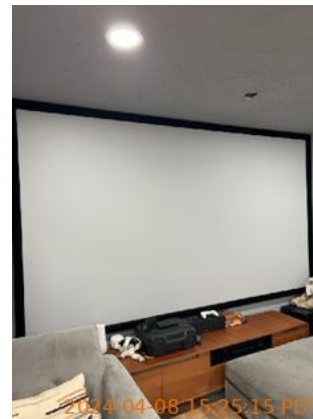
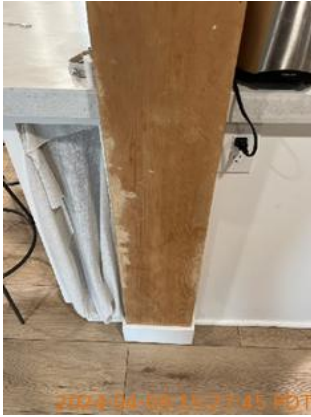
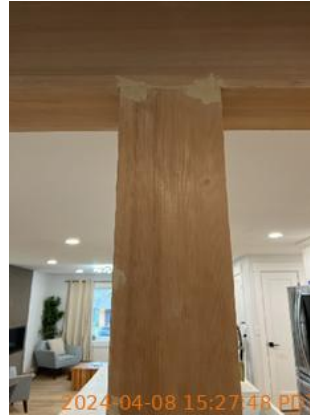
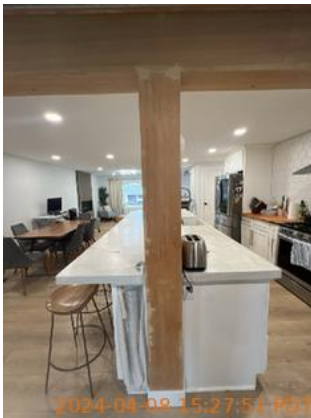
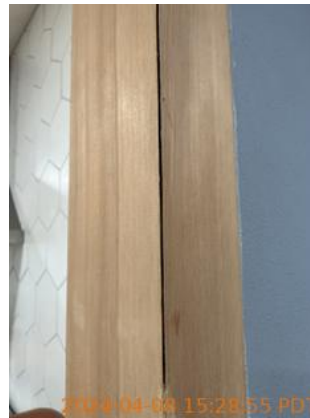
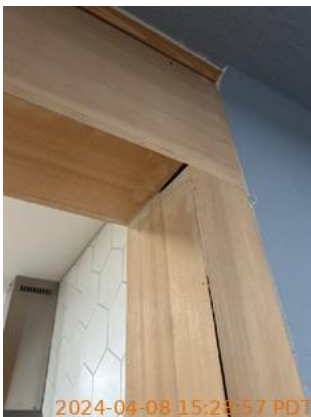
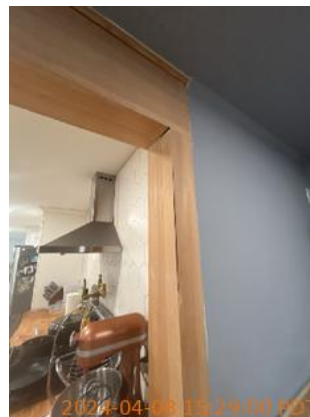
🏠 Living Room	📍 CONDITION	🛠️ ACTION	💬 COMMENTS
Door/Knob/Lock	- S - -	None	
Flooring/Baseboard	- S - -	None	
Light Fixture/Fan	- S - -	None	
Other	- - D -	None	Projector and projector screen added to living room. Paint marks on wood pillars connected to kitchen. Gaps and cracks on wood pillar connected to kitchen.
Switch/Outlet	- S - -	None	
Wall/Ceiling	- - D -	None	Hole in ceiling.
Window Covering	- - D -	None	Curtain rail bracket falling out of wall.

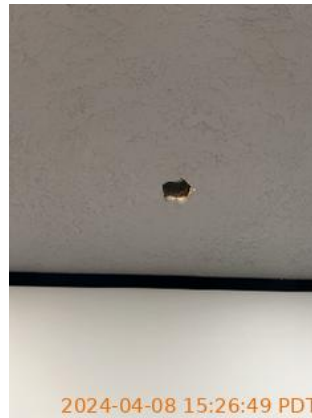
Living Room	CONDITION	ACTION	COMMENTS
Window/Lock/Screen	- S - -	None	
Smoke/CO Detector	- - D !	Maintenance	Missing smoke detector.

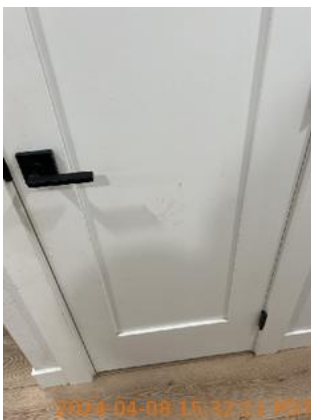
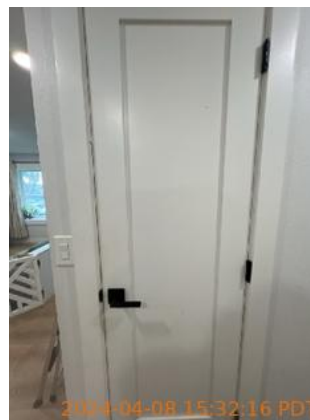
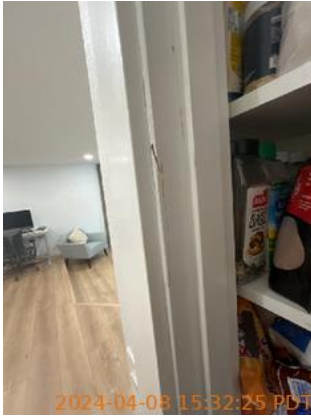
🏠 Hallway/Stairs	📍 CONDITION	🛠️ ACTION	💬 COMMENTS
Closet/Cabinet	- - D -	None	Stains, paint chipping, and wood cracking on closet door.
Flooring/Baseboard	- S - -	None	Stains on wood stairs.
Light Fixture	- S - -	None	
Other	- S - !	Maintenance	Hallway vent is missing a screw.
Railing/Banister	- S - -	None	Very dirty and stained rail.
Smoke/CO Detector	- - D !	Maintenance	Missing smoke alarm.
Switch/Outlet	- S - -	None	
Wall/Ceiling	- - D !	Maintenance	Wiring coming out of hole in wall. Unfinished doorframe.

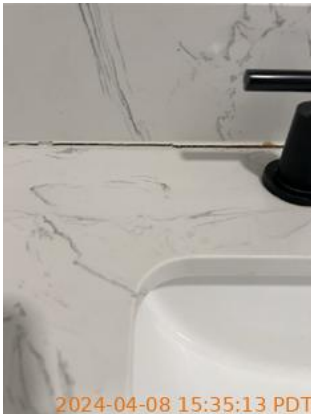
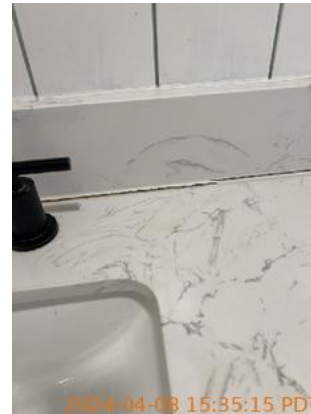
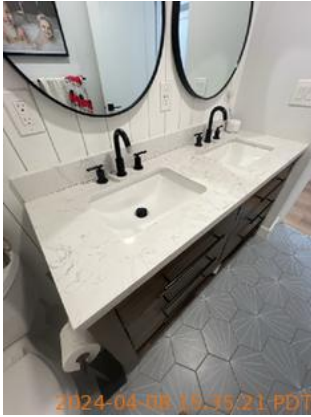
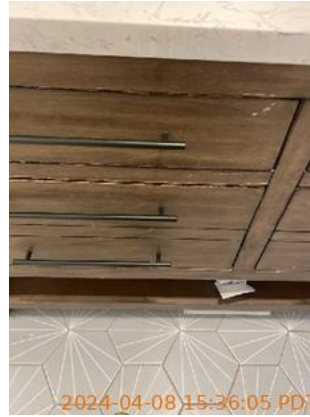
2024-04-08 15:35:13 PDT
Cabinet/Counter/Shelving
 2024-04-08 15:35:13
[45.42474365234375, -122.626385056472](#)
[Image](#)

🚪 Bathroom: Hallway	📍 CONDITION	🔧 ACTION	💬 COMMENTS
Cabinet/Counter/Shelving	- - D !	Maintenance	Cracked caulking where countertop meets wall. Worn finish on cabinets.
Door/Knob/Lock	- S - !	Maintenance	Stains on door. Door needs door stopper.
Exhaust Fan	- S - -	None	Dirty exhaust fan.
Flooring/Baseboard	- S - -	None	Discolored grout on flooring.
Light Fixture	- S - -	None	
Other	- S - -	None	
Plumbing/Drain	- S - -	None	
Shower Door/Rail/Curtain	- S - -	None	
Sink/Faucet	- S - -	None	
Switch/Outlet	- S - -	None

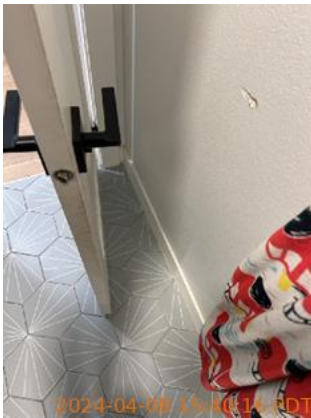
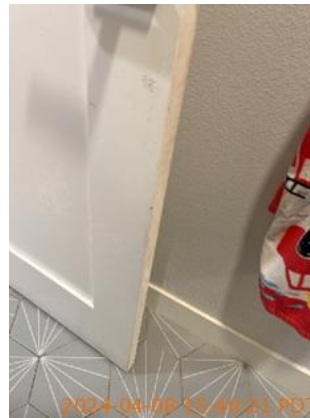
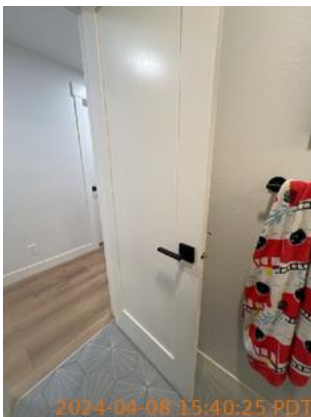
Door/Knob/Lock
📅 2024-04-08 15:40:16
🔍 [45.42474365234375, -122.6263090505294](#)
🖼️ Image

Bathroom: Hallway	Door/Knob/Lock		Maintenance	Stains on door. Door needs door stopper.	     
Bathroom: Hallway	Wall/Ceiling	D	Maintenance	Chipped paint on wall corner edge. Stains on walls. Dent in wall from door handle.

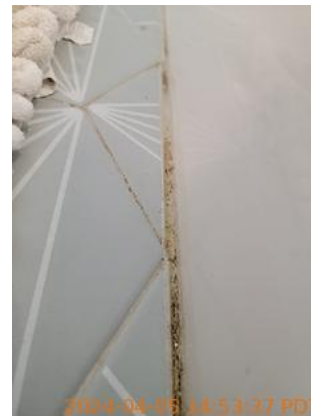
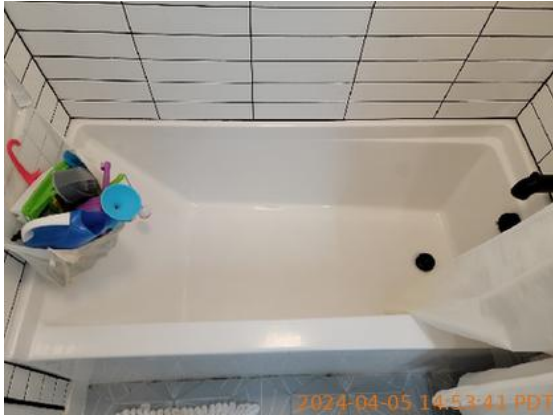
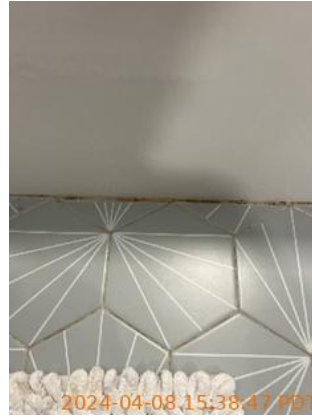
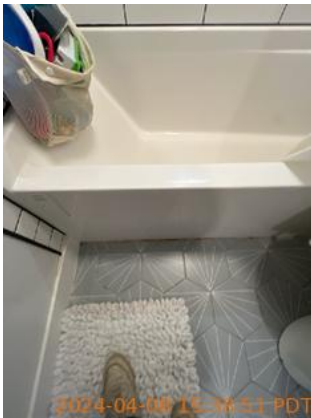
Bathroom: Hallway	CONDITION	ACTION	COMMENTS
Toilet	- S - -	None	
Toilet Paper Holder	- S - -	None	
Towel Rack	- S - -	None	
Tub/Shower	- S - -	None	Discolored grout at base of tub.
Wall/Ceiling	- - D !	Maintenance	Chipped paint on wall corner edge. Stains on walls. Dent in wall from door handle.

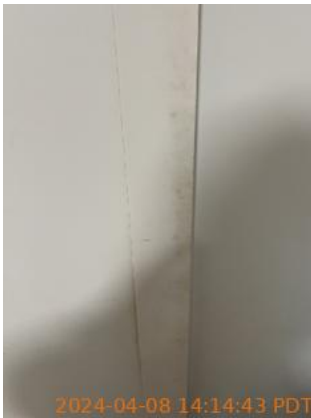
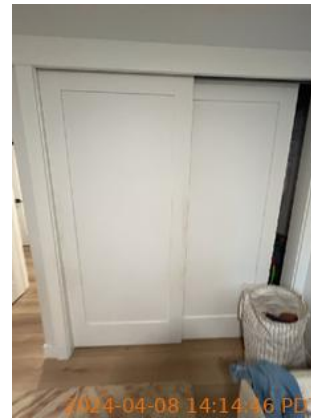
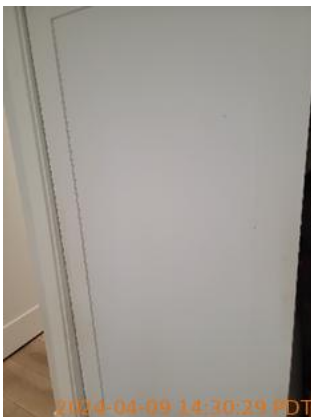
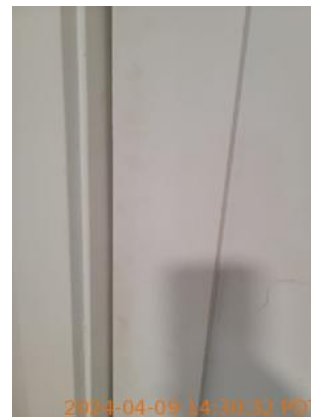
🏠 Bedroom: Southwest	📍 CONDITION	🛠️ ACTION	💬 COMMENTS
Closet/Door/Track/Shelving	- S - -	None	Stains on closet door.
Door/Knob/Lock	- S - -	None	Scuff marks and stains on door.
Flooring/Baseboard	- S - -	None	Floor mostly covered by rug.
Light Fixture/Fan	- S - -	None	
Other	- S - -	None	
Switch/Outlet	- S - -	None	
Wall/Ceiling	- S - -	None	Small marks on walls.
Window Covering	- S - -	None	
Window/Lock/Screen	- S - -	None	Dirty windows.
Smoke / CO detector	- S - -	None	LL w/hush smoke tested.

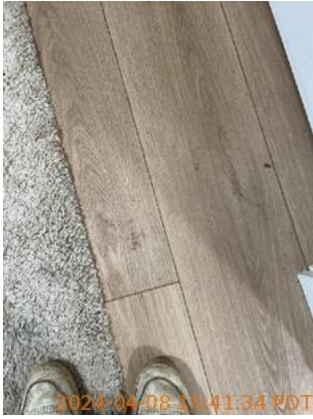
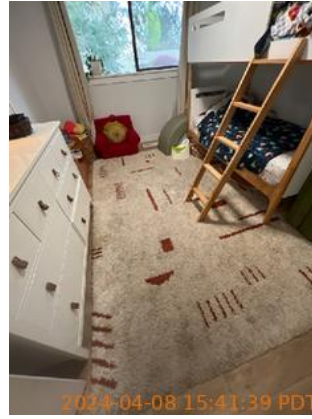
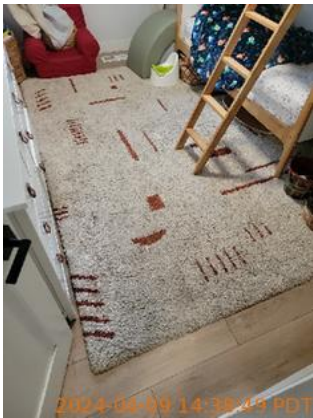
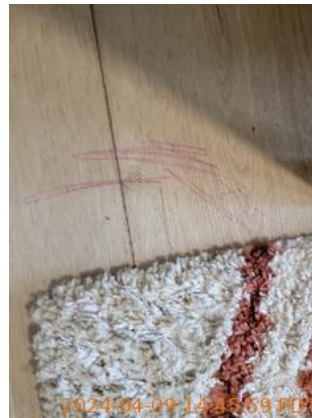
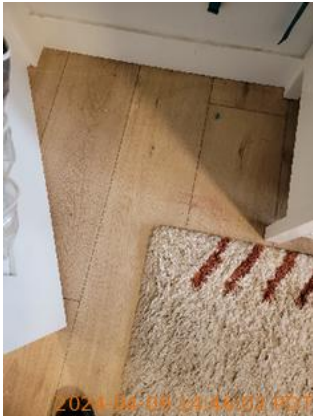
Flooring/Baseboard
📅 2024-04-08 15:41:34
🔍 [45.42471627243368, -122.6261624695013](#)
🖼️ Image

🏠 Bedroom 2: Northwest	📌 CONDITION	🛠️ ACTION	💬 COMMENTS
Closet/Door/Track/Shelving	- S - -	None	
Door/Knob/Lock	- S - -	None	
Flooring/Baseboard	- S - -	None	Stains on floor. Mostly covered by rug.
Light Fixture/Fan	- S - -	None	
Other	- S - -	None	
Switch/Outlet	- S - -	None	
Wall/Ceiling	- - D -	None	Scratched paint, stains and marks on walls and ceiling.
Window Covering	- S - -	None	
Window/Lock/Screen	- S - -	None	
Smoke / CO detector	- S - -	None	LL w/hush smoke tested.

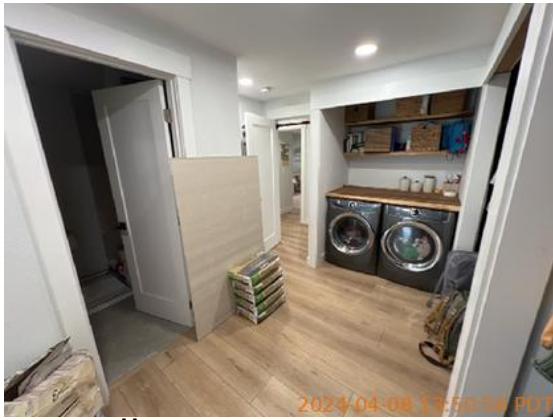
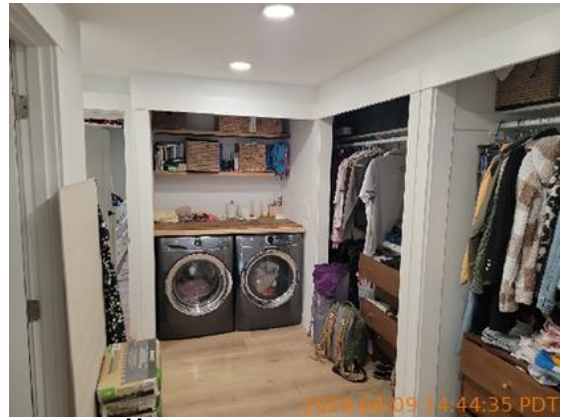
🏠 Laundry Room	📌 CONDITION	🛠️ ACTION	💬 COMMENTS
Cabinet/Counter/Shelving	- S - -	None	
Door/Knob/Lock	- S - -	None	Stains and scuff marks on entry door. Pull up bar attached to doorframe.
Dryer	- S - -	None	
Faucet/Valve	- S - -	None	
Flooring/Baseboard	- S - -	None	Small stains on floor.
Light Fixture/Fan	- S - -	None	
Other	- S - -	None	Building supplies stored in laundry room, rested on walls.
Plumbing/Drain	- S - -	None	
Switch/Outlet	- S - !	Maintenance	Outlet missing plate cover.
Wall/Ceiling	- - D -	None	Visible repair on wall next to outlet. Cracks in wall paint above closet. Scuff marks on ceiling.
Washer	- S - -	None

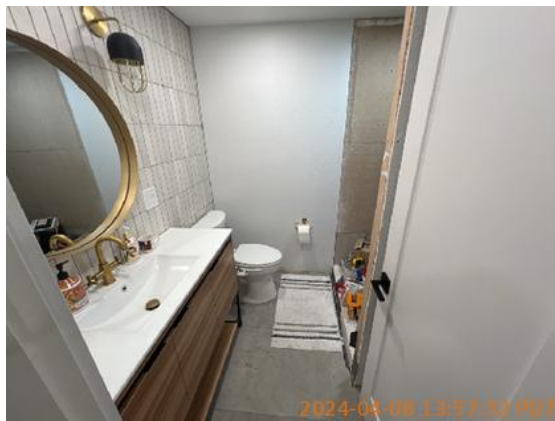
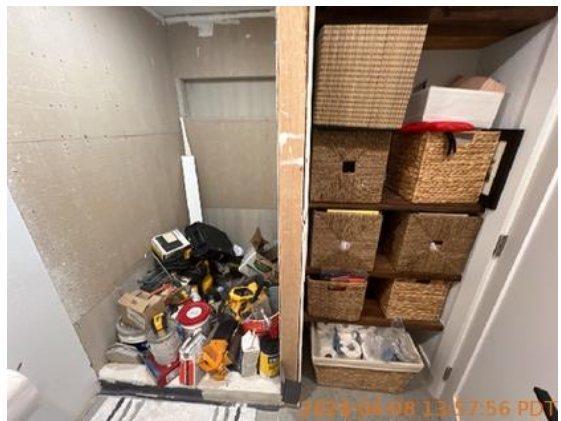
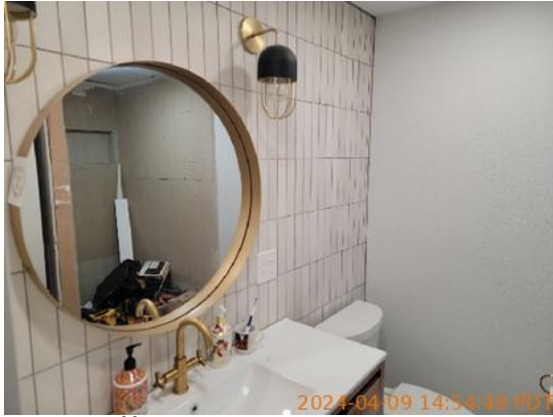
Bathroom 2: Master	CONDITION	ACTION	COMMENTS
Exhaust Fan	- S - -	None	
Flooring/Baseboard	- S - -	None	Stains on floor. Unfinished gap in floor connecting to wall next to toilet.
Light Fixture	- S - -	None	
Medicine Cabinet/Mirror	- S - -	None	Small stains on mirror frame.
Other	- S - -	None	Tools and supplies being stored in unfinished shower.
Plumbing/Drain	- S - -	None	
Sink/Faucet	- S - -	None	Stains on sink finish.
Switch/Outlet	- S - -	None	
Toilet	- S - -	None	
Toilet Paper Holder	- S - -	None	
Towel Rack	- S - -	None	
Tub/Shower	- - D -	None	Shower is unfinished.
Wall/Ceiling	- - D -	None	Unfinished section of wall next to toilet where it connects to floor.

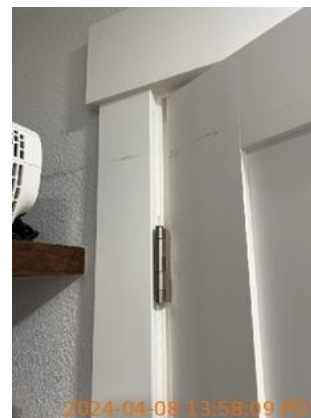
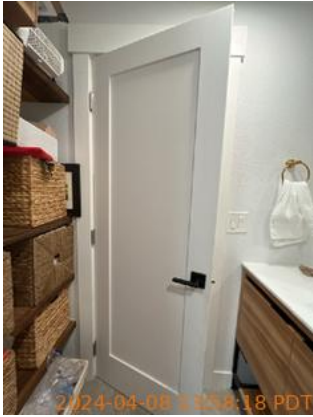
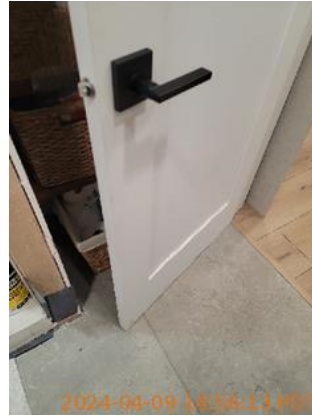
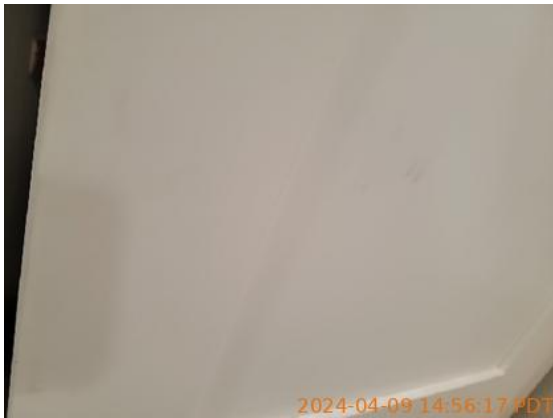
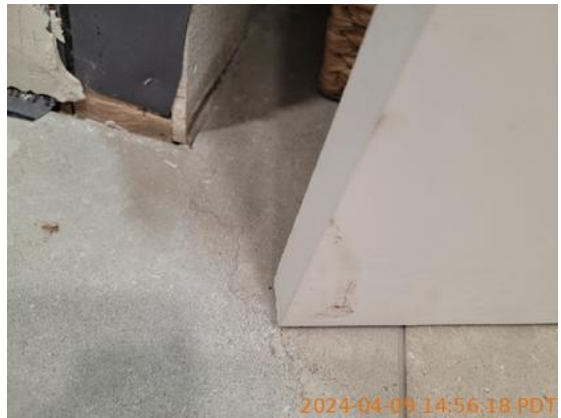
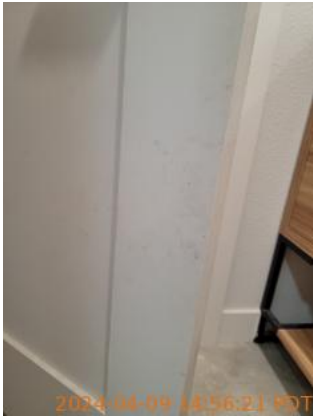
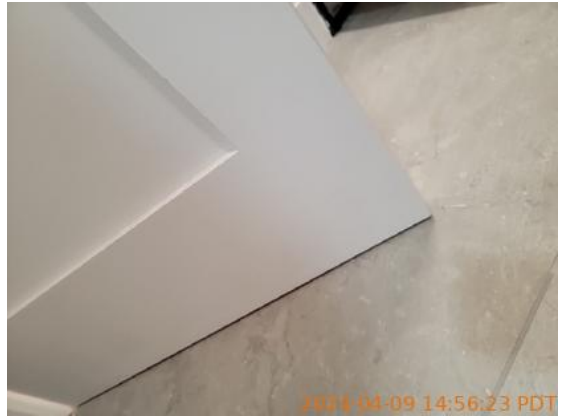
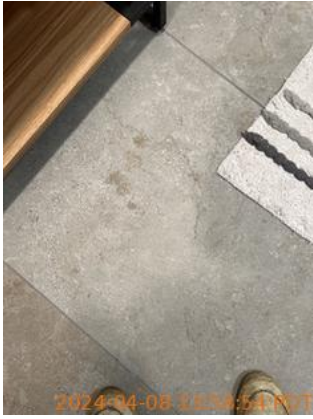
🏠 Bathroom 2: Master	📌 CONDITION	🛠️ ACTION	💬 COMMENTS
Cabinet/Counter/Shelving	- S - -	None	
Door/Knob/Lock	- S - -	None	Stains and scuff marks on entry door.

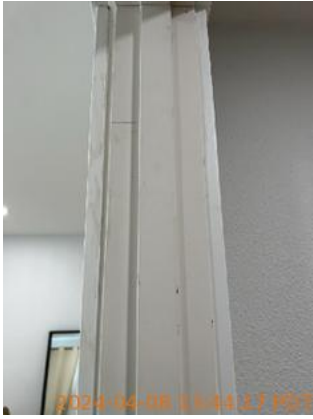
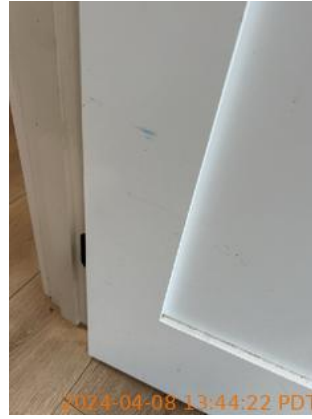
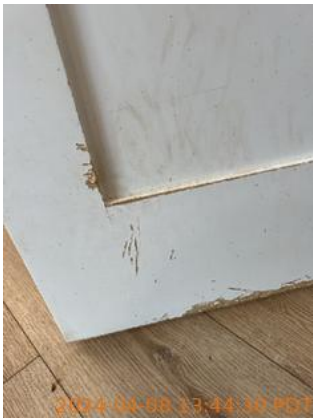
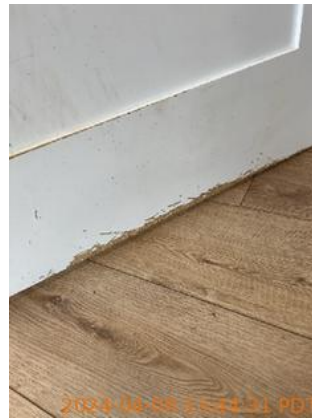
CONDITION	ACTION	COMMENTS
Closet/Door/Track/Shelving	- S - -	None	
Door/Knob/Lock	- - D -	None	Entry door is scuffed marked and gouged.
Flooring/Baseboard	- S - -	None	Small stains on floor.
Light Fixture/Fan	- S - -	None	
Other	- S - -	None	
Switch/Outlet	- S - -	None	Stains on outlet cover.
Wall/Ceiling	- - D -	None	Plastic cover where smoke alarm used to be. Chip in ceiling around plastic cover. Rusty screw in wall leaving a divot. Marks on walls. Building supplies rested on walls.
Window Covering	- S - -	None	
Window/Lock/Screen	- S - -	None	
Smoke / CO detector	- - D !	Maintenance	Missing smoke detector. 1) laundry room LL w/hush smoke tested. (No alarm sound)

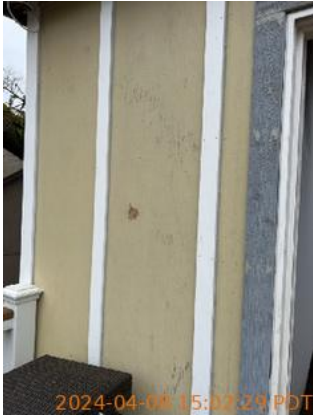
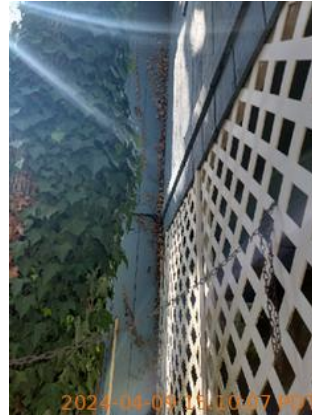
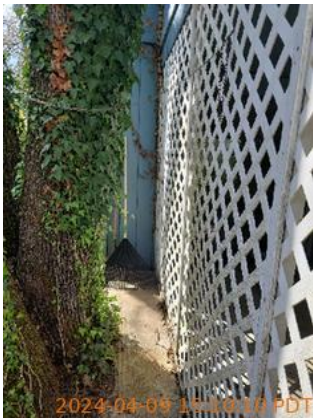
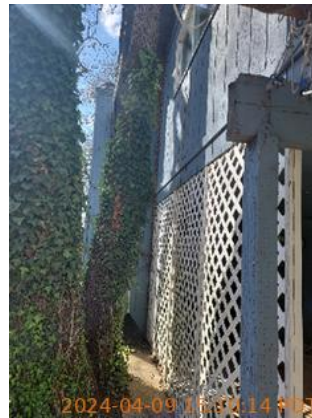
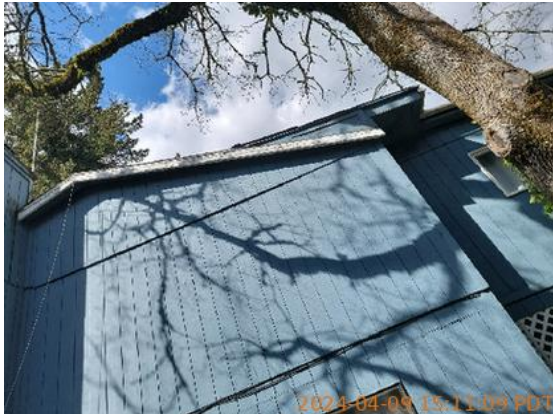
🏠 Back Yard/Exterior	📌 CONDITION	🔧 ACTION	💬 COMMENTS
Building Exterior	- - D !	Landscaping	Ivy growth on siding. Paint chipping on east siding. Missing piece of downspout on NE corner. East side gutter face is dirty and roof flashing is showing rust. Stains and worn paint on East siding.
Fence/Gate	- - D !	Maintenance	Wood gate held closed by rocks. Gate missing latch to close gate properly. Plants growing on east chain link fence. Neighbors ivy growing on far east chain link fence.
Landscaping	- S - !	Landscaping	Bare/patchy grass. Ivy growth in backyard. Weed growth in backyard. Debris in backyard. Overgrown grass area. Stumps and rocks in backyard pose tripping hazard. Divot in backyard poses as a tripping hazard. NE corner of property is overgrown with vines.
Light Fixture	- S - -	None	
Other	- S - !	Other	Frisbee golf net added to back yard. Logs piled up on east side of property. Kayaks stored on back patio. Wood boards stored on back patio. Play structure added to back yard. Slide added to backyard/deck. Lights added to back deck.

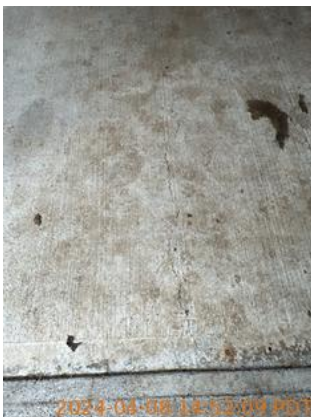
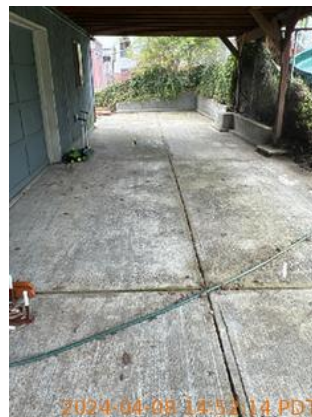
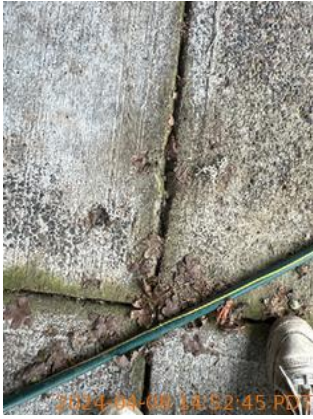
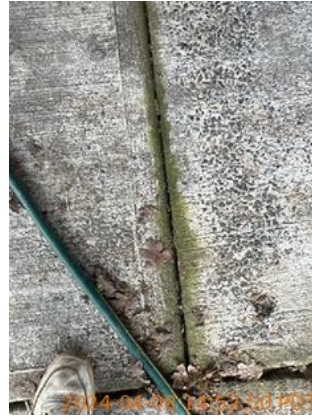
Patio Cover	- S - -	None	
Patio/Deck/Balcony	- - D -	None	Cracks and chips in back concrete patio. Minor moss growth on back patio. Back patio is worn overall. Stains on back deck. Miss match paint on sliding glass door frame.
Porch/Stairs	- S - -	None

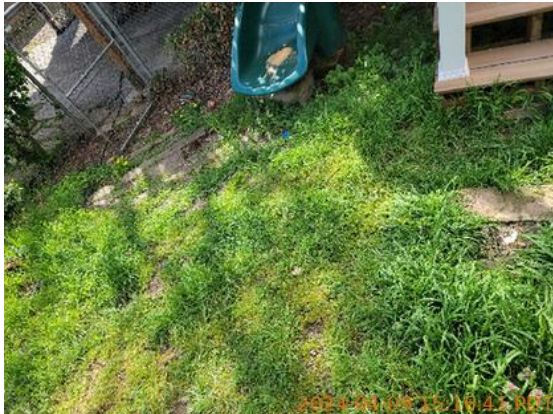
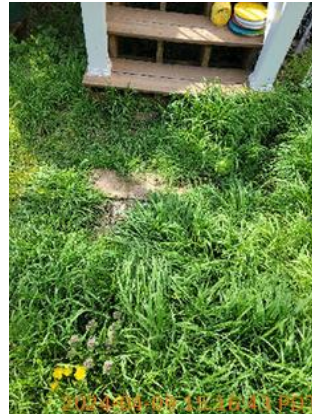
Walkway	- - D -	None	Walkway from patio to deck stairs is cracked and overgrown.
---------	---------	------	---

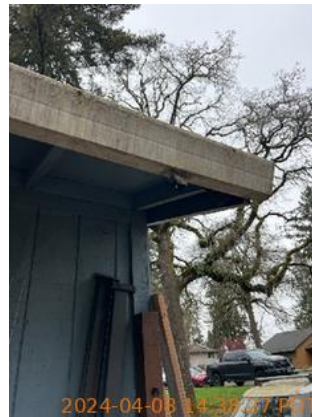
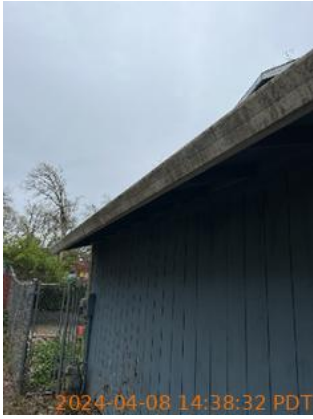
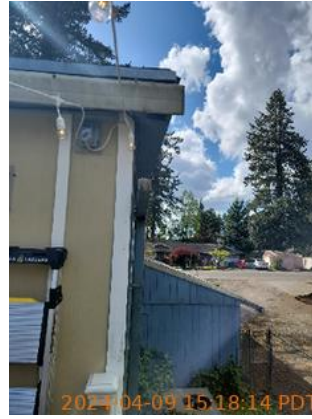
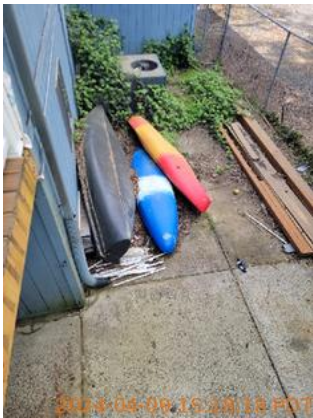
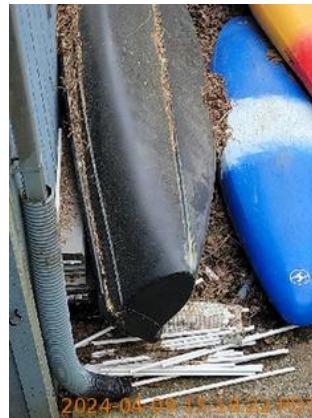
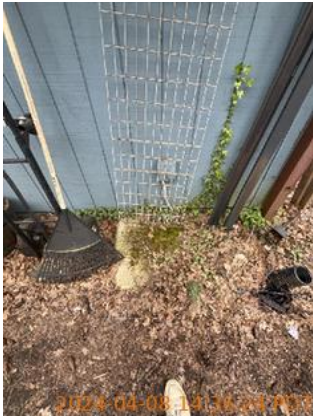
Side Yard/Exterior	CONDITION	ACTION	COMMENTS
Building Exterior	- - D !	Maintenance	Materials rested on siding. Missing north side downspout. Dirty gutter face. Debris in gutters.
Fence/Gate	- S - -	None	
Landscaping	- S - !	Landscaping	Moss, ivy growth, and dead leaves in North side yard.
Light Fixture	- S - -	None	
Other	- S - -	None	
Patio/Deck/Balcony	- S - -	None

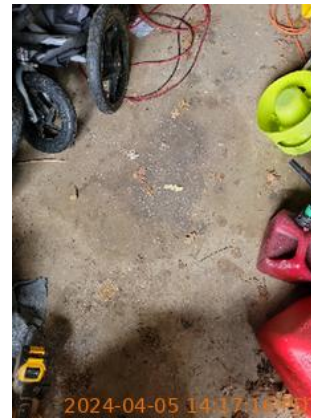
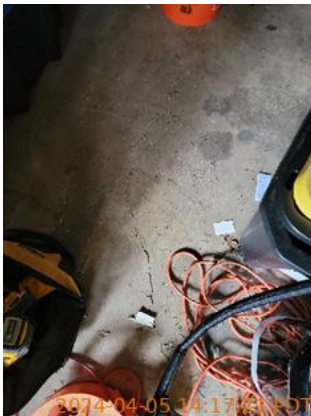
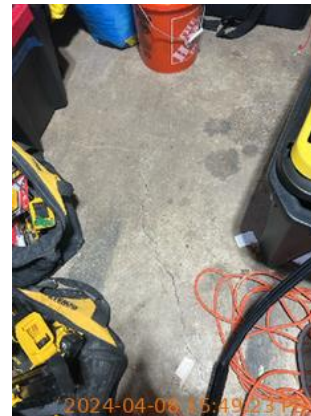
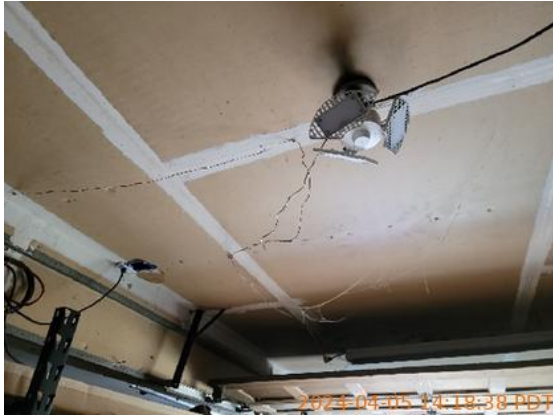
🏠 Garage/Parking	📌 CONDITION	🛠️ ACTION	💬 COMMENTS
Cabinet/Counter	- S - -	None	
Driveway/Floor	- - D -	None	Stained and cracked floor.
Electrical/Exposed Wiring	- - D !	Maintenance	Visible wiring in wall behind breaker box.
Garage Door	- - D -	None	Miss match garage doors. Paint chipping, stains, and wood rot on garage door & frames.
Light Fixture	- S - -	None	
Other	- - D -	None	Garage used for storage. Panels cut out of wall.
Other Door/Knob/Lock	- S - -	None	
Other Storage/Shelving	- S - -	None	
Switch/Outlet	- - D !	Maintenance	Ceiling outlet missing cover plate.

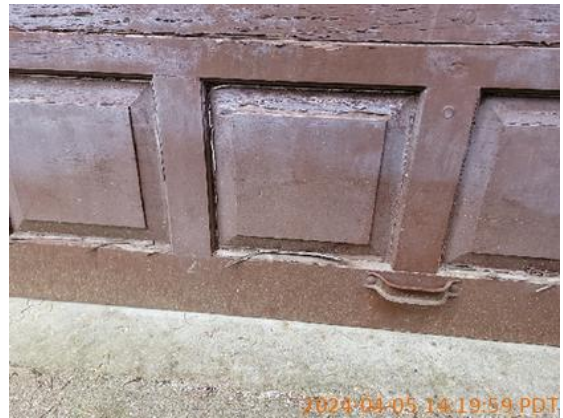
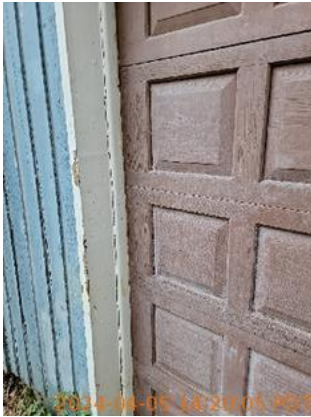
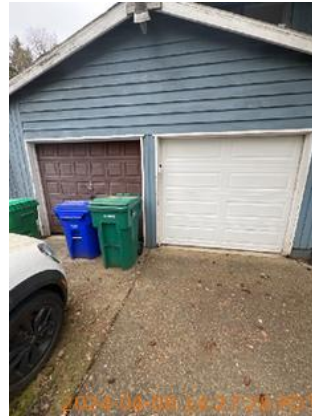
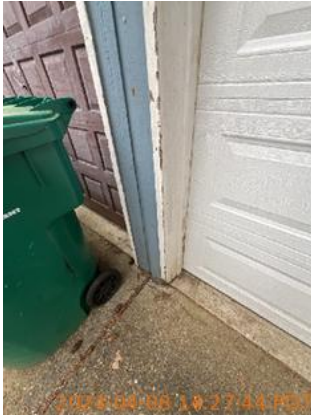
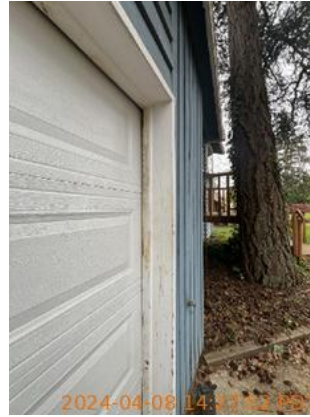
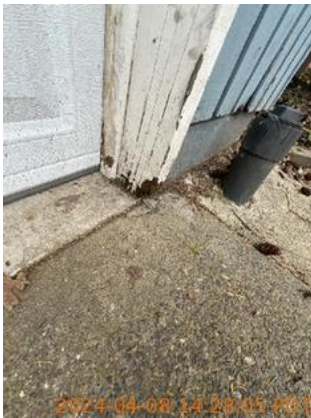
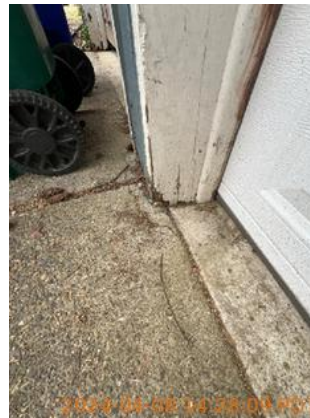
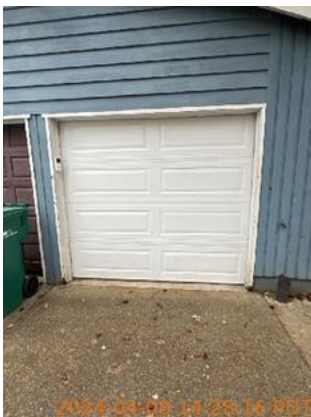
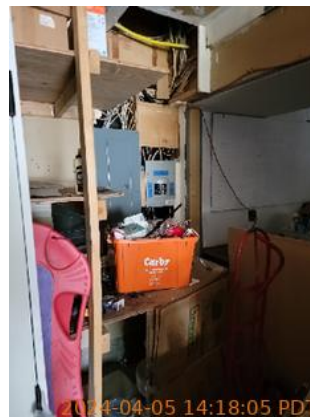
Image
Garage/Parking	Garage Door	D	None	Miss match garage doors. Paint chipping, stains, and wood rot on garage door & frames.
